#### **Traffic Management - QUARRIES**

# Glasshouse Quarry (3559)

# Implementation - North Ramp, Office/Weighbridge & Plant Area

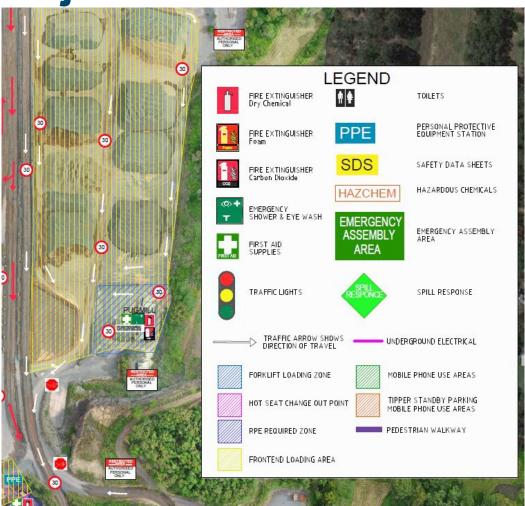
TRAFFIC MANAGEMENT, SAFETY HAZARD &

- Clear view over actual site imagery.
- Displayed in several locations around site in A0 sizing.
- Use of pictographs/grams, purely functional, clear images that everyone agrees on and familiar.
- Easy ability to review and amend.
- Layered annotations to provide flexibility and clarity on specific functions i.e. Electrical services.
- Delineate clear zones for positive communications.

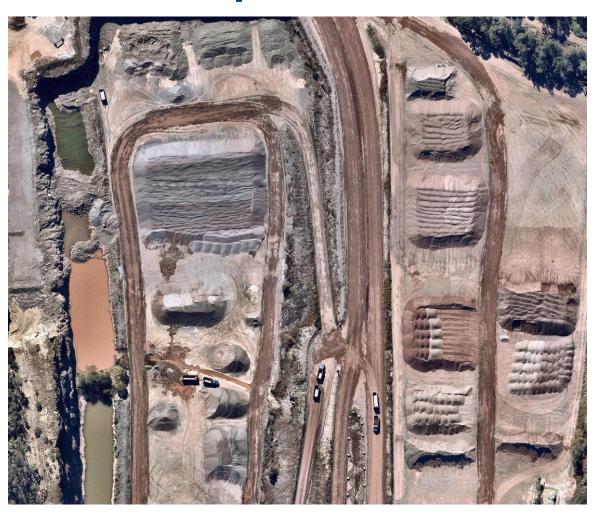
### **North Ramp Relocation**

- North & South
   Ramps one lane, yet
   2 way traffic Lots
   of communication
   over 2 way causing
   congestion.
- Meet at top on level ground – terrible visibility onto main haul road, high exposure.
- Didn't meet Traffic mgmt. guildeline spec's.

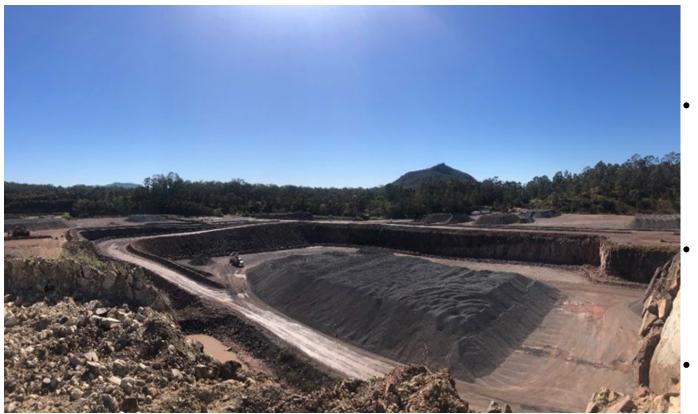
### **North Ramp Relocation**

Load and haul efficiency gain when expectation was actually to have increased L&H times.

- Reduction in 2 way radio traffic and elimination of 2 way traffic on ramp.
- Increased visibility at intersections and approaches in line with Traffic mgmt. guideline.
- Significantly reduced interactions on haul road.
- Removal of previous North ramp and replace in new location.

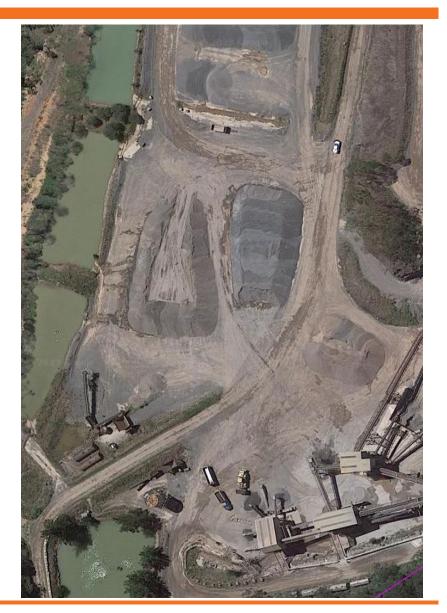
### **Plant Area**

- No clear roadways
- No pause points
- No effective positive communication
- No clear zone owner
- High interaction levels
- Multiple entry/exit points
- All tippers/vehicles entering quarry must pass through this area
- Stockpiles creating visual obstructions
- Plant operations either side of thoroughfare

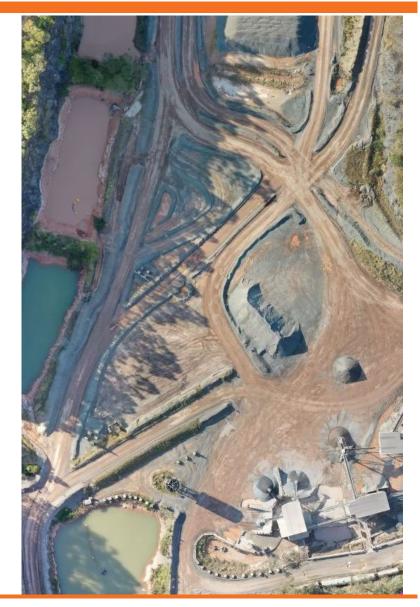
### **Plant Area**

- Clear roadways
- Pause points incorporated at entry points
- Positive communication process established
- Zone owner assigned to plant loader role
- Interaction levels reduced by diverting 85% of incoming traffic
- Multiple entry/exit points managed
- Only Tippers being loaded form plant now directed in by zone owner
- 1 stockpile remains, demarcated and diversion minimise risk
- Wash plant decommissioned

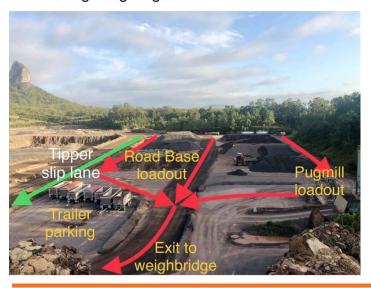
This year traffic management has been a key focus on keeping our people safe. Some of they ways we are working to reduce our exposure is demonstrated in the photo below. Segregation is critical between pedestrians and all vehicles, along with dedicated road tipper lanes to reduce interactions with heavy machinery. One way traffic flow and good visibility in intersections is another area we are continually improving with feedback from operators, road tippers and light vehicles critical in getting it right!

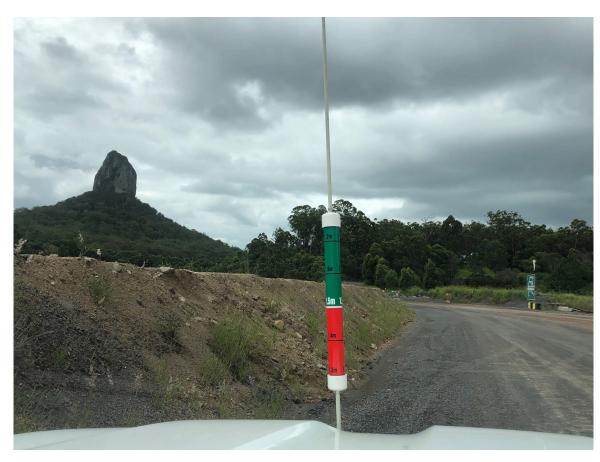
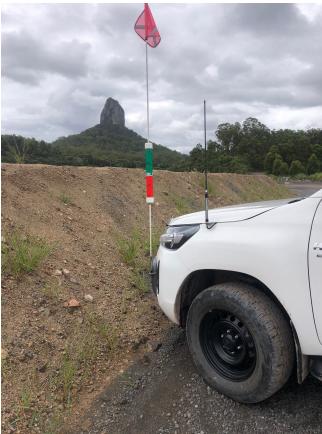
# **Edge Protection Height Measuring Flag**

- Site based innovation developed by supervisor Barrie Dobson.
- Intent to reduce pedestrian access to haul roads to confirm edge protection heights.
- Noted that measuring edge protection with a tape measure was not effective.
- Solutions being explored relied on technology and therefore were not cost effective.
- This was extremely cost effective and easily reproduced by any site and the sign writers.
- Significant exposure reduction and gives a very clear indication on edge protection compliance instantly.

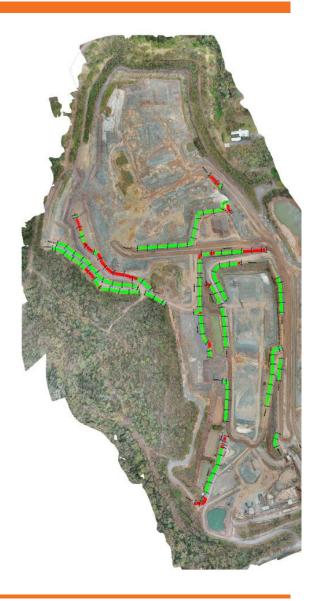
#### Edge Protection

Data supplied by:NSSdrones.com Date Captured:29/09/2021 Survey type: UAV survey Contours interval:5m

Cross section interval: 20m Height Compliance measurement interval: 5m Height measured from crest to Horizontal 5m offset

NOTE:Height compliance measured at 5m intervals

Less then 1.5m Greater than 1.5m

- Drone survey to confirm our edge protection compliance.
- Provides clear understanding of where any areas of concern are located.
- Each area assessed immediately and remediation work or barricading put in place.
- Determination between edge protection & segregation bunding.
- Formally noting in risk report results and actions including any anomalies which appear that may form drains etc.
